ALABAMA HAZARDOUS WASTES MANAGEMENT AND MINIMIZATION ACT (AHWMMA)
Compliance Evaluation Inspection (CEI) Report

Sejong Alabama, LLC (Sejong)
450 East Old Fort Road
Fort Deposit, Lowndes County, Alabama 36032

March 21, 2016

ATTACHMENT – SEJONG ALABAMA LLC PHOTO LOG

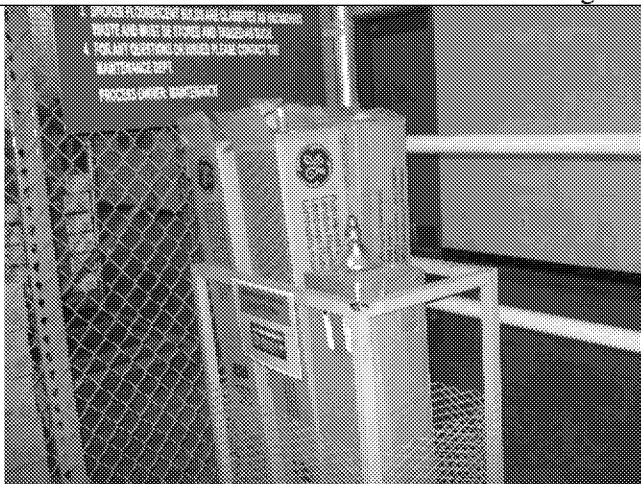
- The four boxes containing UW lamps were not marked or closed (the flaps were not closed or sealed).
- The uncontained HID lamp was placed on top of the box containing the broken lamps. It appeared to be intact but was not marked in any way. Representatives of Sejong were not sure if this lamp was a waste (it was subsequently managed as UW).
- The drum that contained the spent paint pens was closed but was not marked with the words “Hazardous Waste” with other words describing the content. The pens contained xylene and are disposed as an ignitable (D001) hazardous waste.
- The containers holding the UW Ni-Cad and Lithium ion batteries were both closed and properly marked but were not dated.
- The UW lead-acid batteries were intact but were not marked or dated.

The facility representatives were not able to demonstrate the length of time that universal wastes had been accumulated on site. As a further matter, they were unable to describe how they intended to manage the spent lamp ballasts or the microwave ovens. See Photograph #2 through Photograph #5.

2. Universal waste lamps, including one not contained

(In an email dated March 23, 2016, Mr. Blake Miley responded to the *Preliminary Inspection Report* form that was issued at the time of the inspection, declaring all UW items had been properly contained, labeled, and dated and the marking on the drum holding the paint pens had been corrected.)

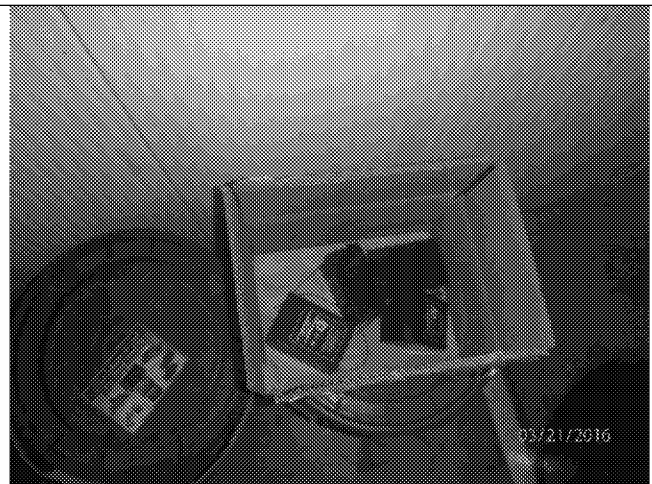
3. Universal waste lead-acid batteries

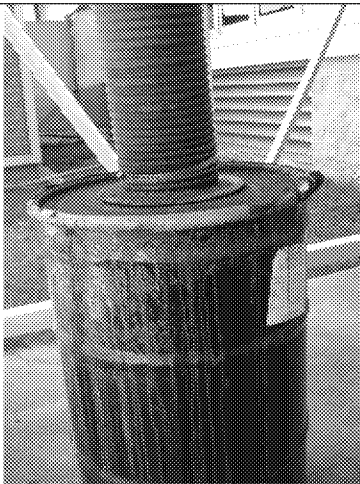
the unit; both were closed and marked with the words “Hazardous Waste”, but neither container was marked with an accumulation start date. One drum appeared to be significantly rusted. The “return air” duct was vented to the outside; per Mr. Kim and Ms. Speir, the air returned from the filtration unit was either too hot or too cold, making it difficult to control the air temperature inside the plant. See Photographs #9 – #11.

- Sejong stored hazardous waste in containers that were not in good condition. Four of the drums associated with the baghouses were rusted or had rusted lids.

10. UD Baghouse – Rusted drum

(In an email dated March 23, 2016, Mr. Blake Miley responded to the *Preliminary Inspection Report* form and declared: all full containers were moved to the hazardous waste storage area; the rusted containers and lids had been replaced; lids that shed water had been ordered; and all drums had been correctly labeled.)

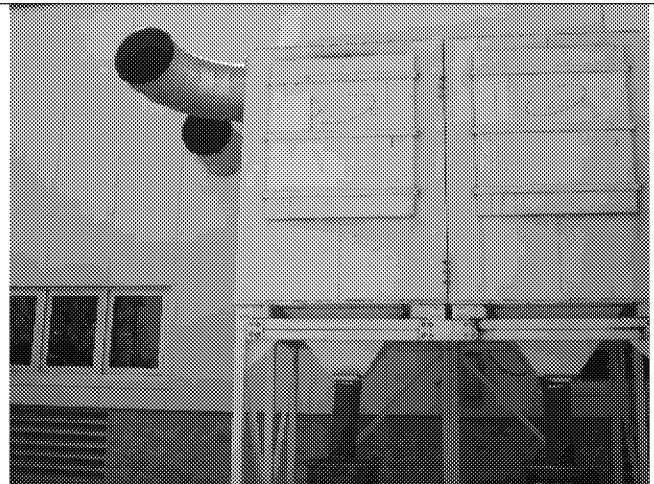
11. UD Baghouse – Return air disconnected

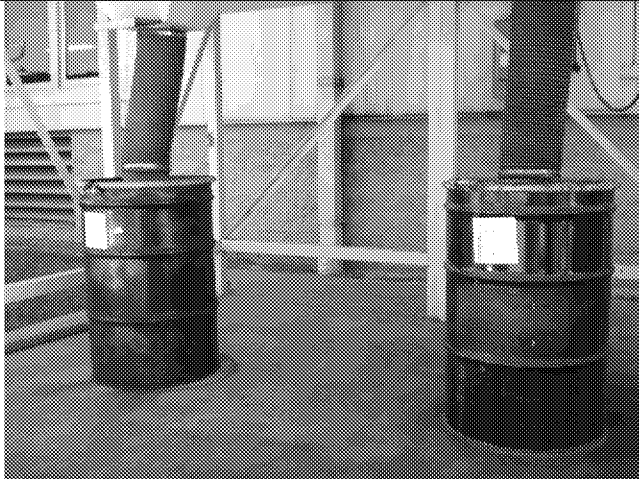
The “WCC1” unit is located along the east wall of the plant between the “UD” unit and the “WCC2” unit. It services the engine line, rather than a specific vehicle. There were two 55-gallon drums at this baghouse; one was about 75% full, while the other was about 25% full. Both were marked with the words “Hazardous Waste” and were closed, but the lids appeared to be significantly rusted. Neither container was marked with an accumulation start date. Again, the “return air” duct was vented to the outside to make it easier to control the air temperature in the vicinity of the unit. See Photographs #12 and #13.

12. WCC1 Baghouse

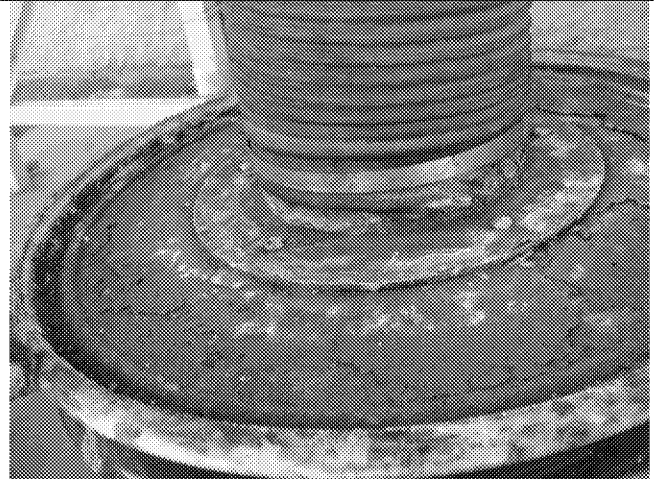
13. WCC1 Baghouse – rusted baghouse connector

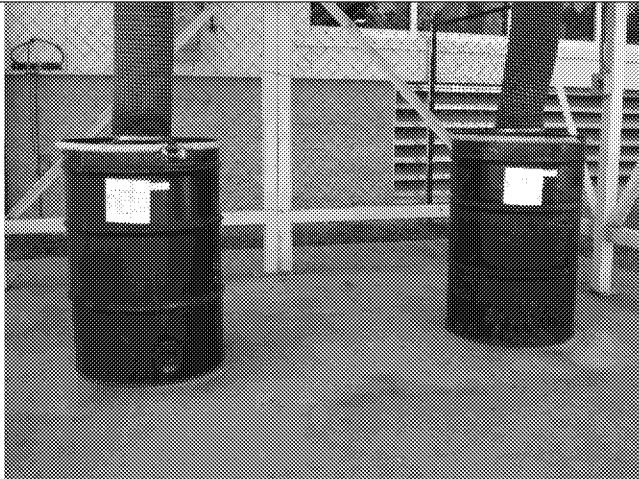
The “WCC2” unit is located near the south east corner of the building. It also services the engine line. Two full 55-gallon drums were attached to the unit. Both were in good condition, marked with the words “Hazardous Waste”, and were closed. They were not marked with an accumulation start date. See Photograph #14

14. WCC2 Baghouse

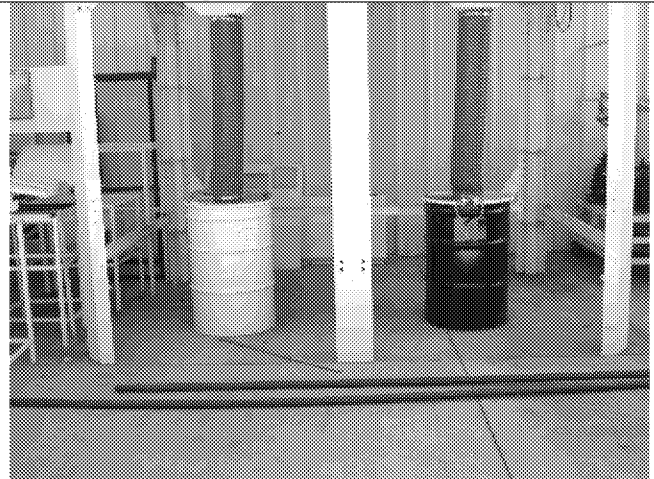
The “Rework” baghouse is located near the center of the north wall of the plant and serves the Rework Area, where faulty welds are redone. Two partially-filled 55-gallon drums were attached to this baghouse. Both were closed and in good condition. One was marked with the words “Hazardous Waste”, while the other was neither marked nor labeled. See Photograph #15

- Sejong did not mark all satellite accumulation containers holding hazardous waste with the words "Hazardous Waste". One 55-gallon drum holding chromium dust and one 55-gallon drum holding spent paint pens were not marked in any way.

15. Rework Baghouse
